Manhole Inspection Summary

Manhole # S4100_004MH

Insp Date: **2/21/07 11:10 AM**

Location Address: **2319 ROBB ST**

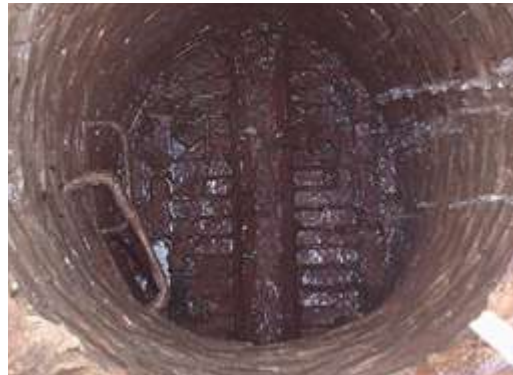
Top View

Bench ☒ Exists Material: **Brick** ☐ Parged ☒ **Debris** (not Condition related)

Steps Count: **2** Missing: **0** ☒ **Corroded**

Corroded steps. Bench debris.

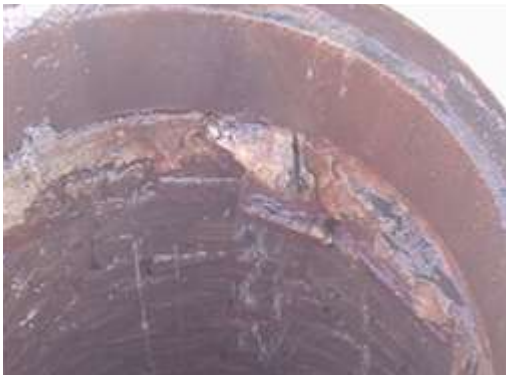
Inflow from the Alley

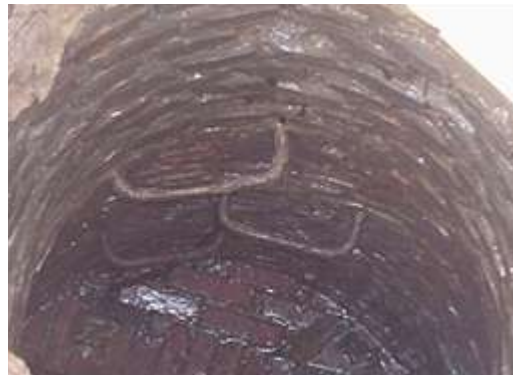
Defect

Corroded steps

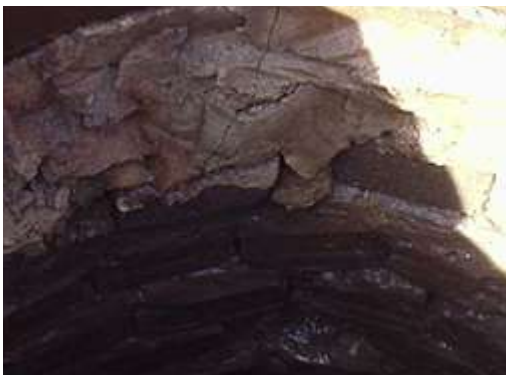
Defect

Condition: ☐ Sound ☐ Cracked ☐ Root Intrusion ☐ Loose Brick ☒ **Deteriorated**

Infiltration: ☐ None ☒ **Joint** ☐ Cracks ☐ Mortar ☐ Roots ☒ **Wall**

Corbel deterioration and infiltration.

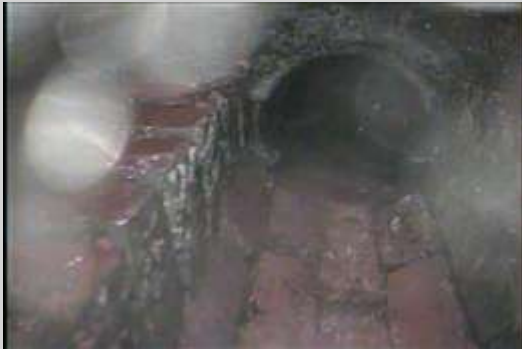
8 in. Circular Gravity Sewer Pipe Out @ 12 O'Clock

Infiltration: **Evidence** Pipe Seal Cond: **Unknown**

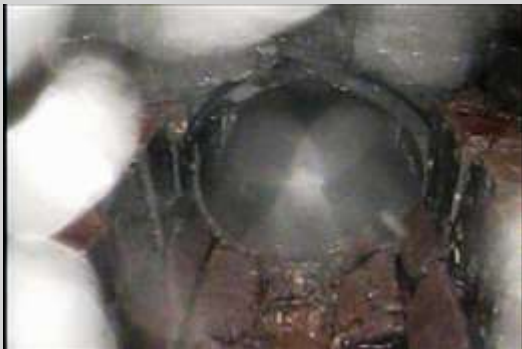
8 in. Circular Gravity Sewer Pipe In @ 6 O'Clock

Condition: ☐ Sound ☐ Cracked ☐ Root Intrusion ☒ **Deteriorated** ☐ Leaks ☐ Debris

Channel deterioration.

Infiltration: **None** Pipe Seal Cond: **Broken**
